Non Ceramic Insulator Workshop

Presented by R. Allen Bernstorf
The Dalles, Oregon
May 6, 1993

**NON CERAMIC INSULATOR WORKSHOP
PRESENTED BY R. ALLEN BERNSTORF
THE DALLES, OREGON
MAY 6, 1993**

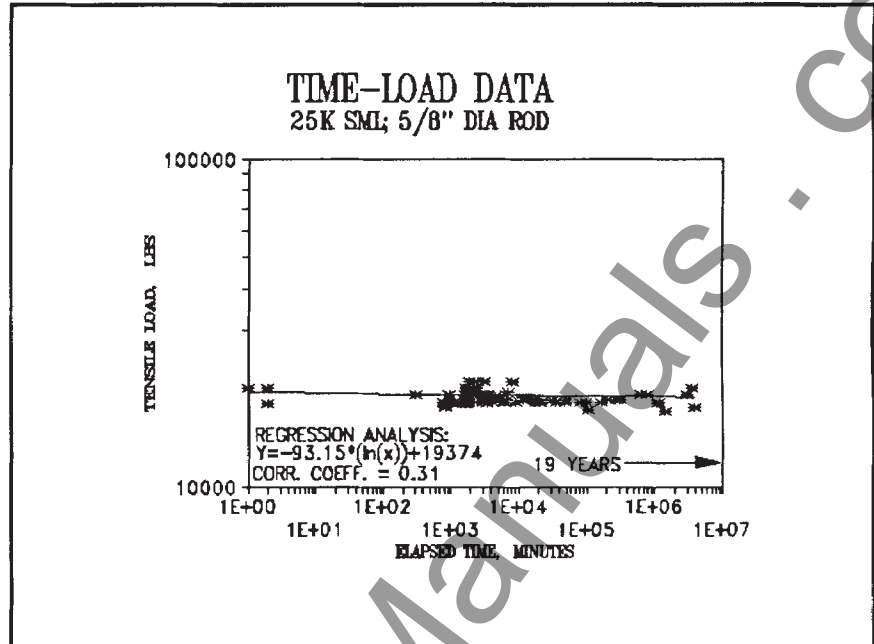
FIGURE 16

Time-load deals with the ability of an insulator to support a given load for a long period of time. It is often confused with the ultimate strength of the insulator at any given point in time. The data plotted in figure 16 represents constant loads applied for some time period; in this case, until failure of the specimen occurs.

In other words, the insulator is loaded rapidly to a high level and then that load remains constant until the sample fails.

The curve (figure 16) represents data collected on insulators with a rod size equivalent to that used in Ohio Brass's current 25,000 lb SML insulators. The word "equivalent" should be emphasized. When these insulators were manufactured with a 5/8" diameter rod, the guaranteed minimum ultimate strength was 20,000 lbs. Each of the asterisks represent a failure point.

For the sake of completeness, a logarithmic regression has been

performed on this data. That equation is shown on the plot. The correlation for time-load data is typically not very good, but it gives a general idea of the slope of the curve.

Please note that the regression line does not pass through the current SML for this rod size, nor does it threaten the RTL at any time in the foreseeable future. More than 95% of the insulators

which fail in time-load testing are rod failures. What this appears to indicate is that the time-load test is a good measure of the capabilities of the rod used in the manufacture of the insulator.
