SIMOVERT MASTERDRIVES Motion Control

Betriebsanleitung Operating Instructions

Wechselrichter (DC-AC) Bauform Kompakt Inverter (DC-AC) Compact Type

Bestell-Nr. / Order No.: 6SE7087-6KD50

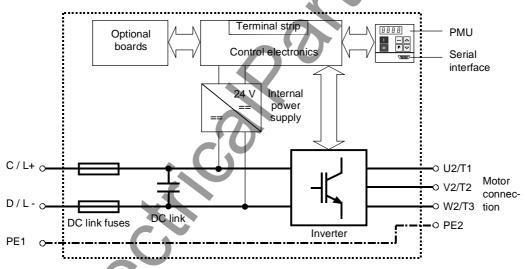
Fig. 2-1 Circuit principle of the inverter

With option L33 "Compact unit without DC fuses" the DC fuses are replaced by conductive connections.

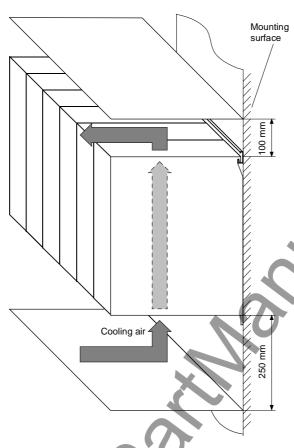
Fig. 5-1 Minimum clearances for cooling

The ambient climate of the units must not exceed the values of DIN IEC 721-3-3 class 3K3. For cooling air temperatures of more than 40°C (104°F) and installation altitudes higher than 1000 m, derating is required.

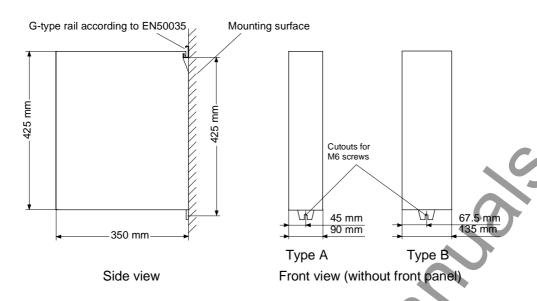
Fig. 5-2 Dimension drawings for installation of types A, B

- ◆ G-type mounting rail according to EN50035 with screws for fixing at the top
- One M6 screw for types A to C, two M6 screws for type D, for fixing at the bottom
- Dimension drawing for types A, B and for types C, D.

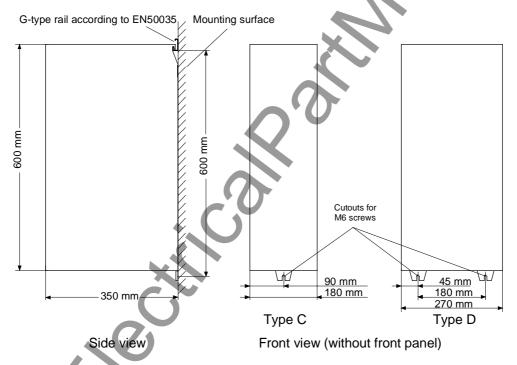
Fig. 5-3 Dimension drawings for installation of types C,D

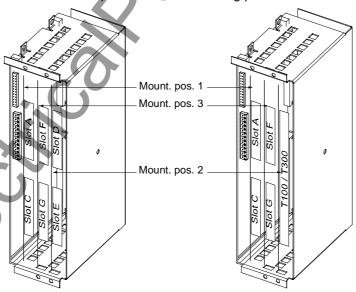
♦ Slot A	CU board	Position: top
♦ Slot C	CU board	Position: bottom
♦ Slot D	Adaption board at mounting position 2	Position: top
♦ Slot E	Adaption board at mounting position 2	Position: bottom
♦ Slot F	Adaption board at mounting position 3	Position: top
♦ Slot G	Adaption board at mounting position 3	Position: bottom

Fig. 5-4 Position of the slots in the electronics box

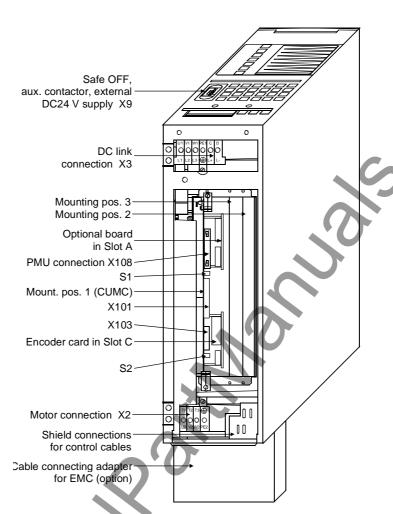
Fig. 7-1 Connection overview of types A, B, C

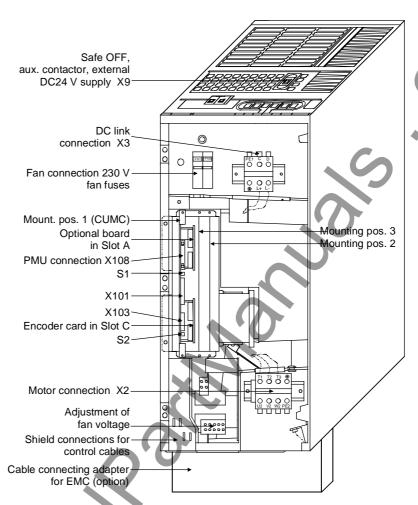
Fig. 7-2 Connection overview of type D

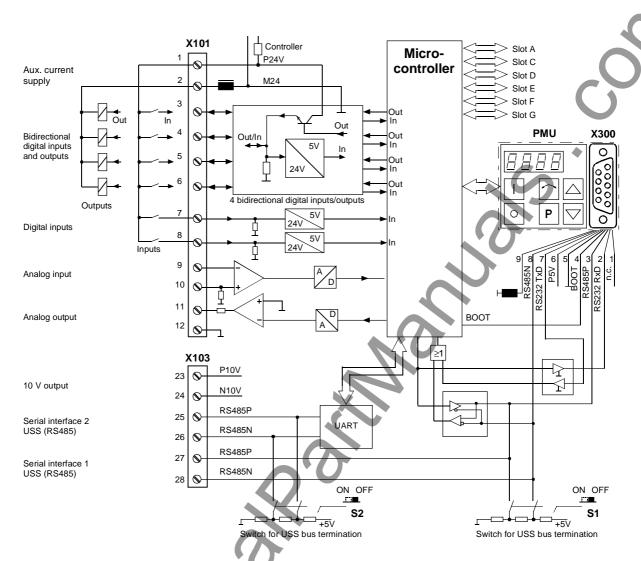
Fig. 7-4 Overview of the standard connections

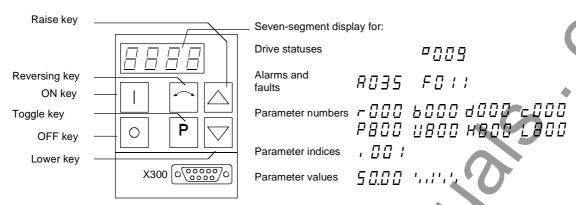
Fig. 8-1 PMU parameterizing unit

Key	Significance	Function	
	ON key	For energizing the drive (enabling motor activation).	
		If there is a fault: For returning to fault display	
0	OFF key	For de-energizing the drive by means of OFF1, OFF2 or OFF3 (P554 to 560) depending on parameterization.	
	Reversing key	For reversing the direction of rotation of the drive. The function must be enabled by P571 and P572	
Р	Toggle key	 For switching between parameter number, parameter index and parameter value in the sequence indicated (command becomes effective when the key is released). If fault display is active: For acknowledging the fault 	
	Raise key	For increasing the displayed value:	
		Short press = single-step increase	
		Long press = rapid increase	
	Lower key	For lowering the displayed value:

Parameter changes made using the PMU are always safely stored in the EEPROM (protected in case of power failure) once the toggle key has been depressed.

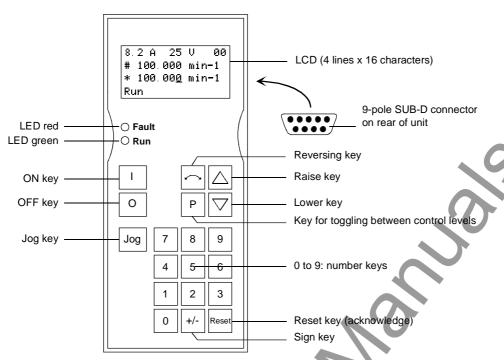
Fig. 8-2 View of the OP1S

Parameter changes made using the OP1S are always stored safely in the EEPROM (protected in case of power failure) once the toggle key (P) has been pressed.

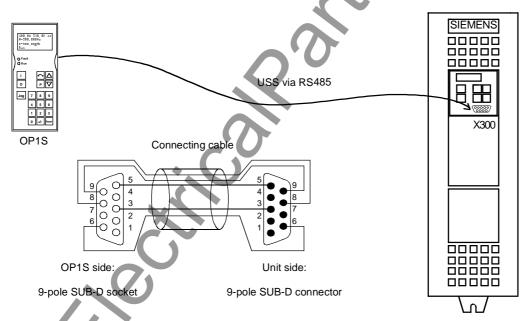
Fig. 8-3 The OP1S directly connected to the unit

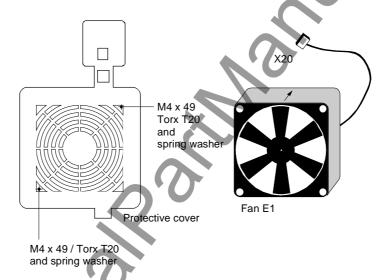
- ♦ Undo the two M4x49 Torx screws
- Pull out the protective cover together with the fan from underneath
- ♦ Withdraw fan connector X20
- Install the fan in reverse sequence.

Fig. 9-1 Cover and fan for housing size A to C

The fan is designed for an operating time of $L_{10} \ge 35\,000$ hours at an ambient temperature of $T_u = 40\,^{\circ}\text{C}$. It should be replaced in good time to maintain the availability of the unit.

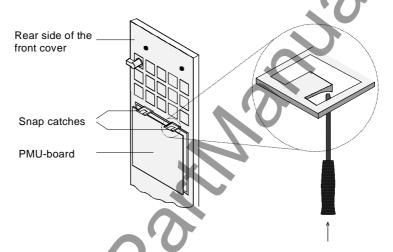
- Turn the snaps on the front cover by 90 °
- Open up the front cover
- Withdraw connector X108 on the CU (Control Unit)
- Remove ribbon cable from the guide hooks
- Carefully press the snap catches upwards on the inner side of the front cover using a screwdriver
- ◆ Tilt the PMU and remove it
- Install new PMU in reverse sequence.

Fig. 9-4 Replacing the PMU

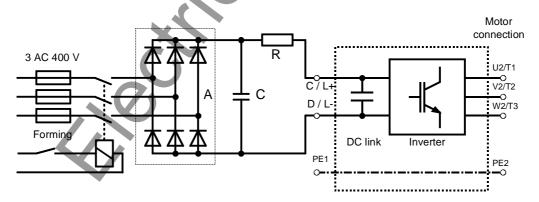
During forming, the DC link of the unit is connected up via a rectifier, a smoothing capacitor and a resistor.

As a result, the DC link capacitors receive a defined voltage and a limited current, and the internal conditions necessary for the function of the DC link capacitors are restored.

Fig. 10-1 Forming circuit

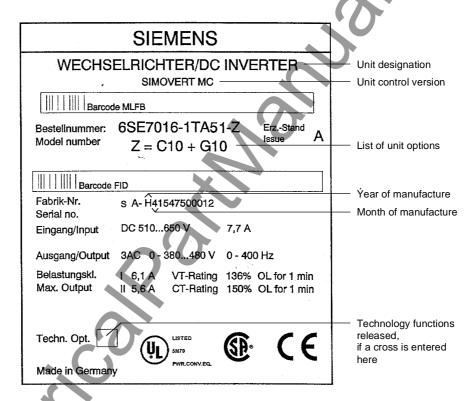
Fig. 11-2 Rating plate
