FIELD TESTING OF GENERAL ELECTRIC TYPE OVERCURRENT TRIP DEVICES

FIELD TESTING OF GENERAL ELECTRIC TYPE OVERCURRENT TRIP DEVICE

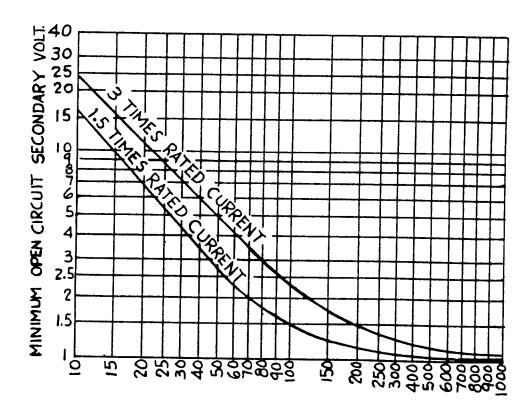
AMPERE RATING OF TRIP DEVICES FIG- 1

external impedance can then be inserted as required to control the test current. Figure 1 shows these open circuit voltage requirements for various coils. This voltage can be quickly checked after the current has been set by measuring the voltage with the breaker open and the test set "on" at the level required to produce 300% continuous current.

In addition to being capable of producing current levels approximately 300% of trip coil rating, the current must be reasonably sinusoidal. Since overcurrent trip devices are designed to saturate slightly above continuous rating to avoid destructive forces at short circuit levels of overcurrent, the devices represent a non-linear impedance at current levels recommended for time delay testing. If the trip device represents the predominant impedance in the test circuit, a non-sinusoidal current wave shape results. To maintain a reasonably sinusoidal wave shape of current, air core reactance should be inserted in the series circuit. The air core reactance must represent the predominant reactive (and linear) impedance to minimize the effect of the trip device impedance. Insertion of this additional impedance in turn requires an increase in test voltage. The minimum external impedance requirement varies for each coil size. The smaller the rating of the trip coil, the higher becomes its impedance, the more external impedance is required, hence the higher the required source voltage. Rather than specify the external impedance required for each coil rating, it is more convenient to indicate the open circuit voltage required for various coil ratings. The
